HADITHA GENERAL HOSPITAL
UNDER THE ECONOMIC SUPPORT FUND PROGRAM
HADITHA, IRAQ

SIGIR PA-08-132
JANUARY 23, 2009

SUBJECT: Report on Project Assessment of the Haditha General Hospital, Haditha, Iraq
(SIGIR Report Number PA-08-132)

Haditha General Hospital Under the Economic Support Fund Program Haditha, Iraq

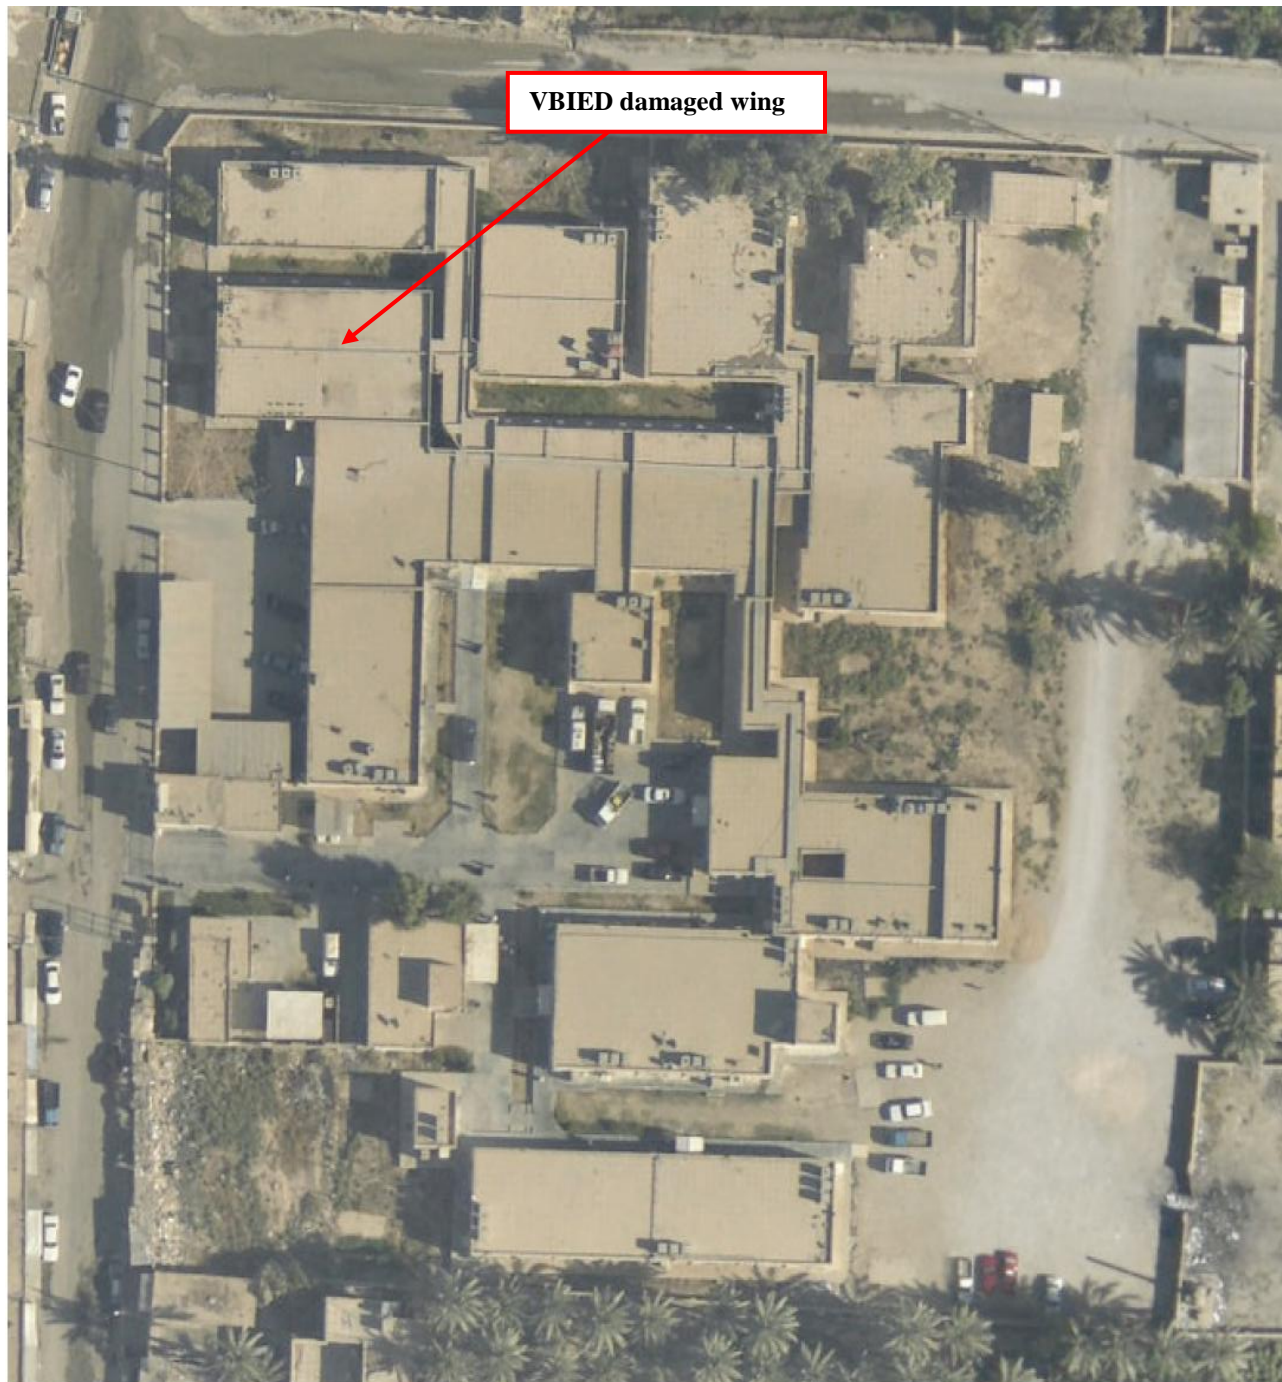
**Figure 1. Aerial photo of the Haditha General Hospital
(Courtesy of USACE)**

The hospital, located in the heart of the city, is a sprawling single-story complex spread out over a city block about 500 meters on each side (Figure 1). It consists of eight interconnected wings, which were built at different times. The complex also includes two other clinic buildings, storage, morgue, ambulance garage, housing, guardhouse, and generators. A large area on the eastern side of the complex allows for possible expansion.

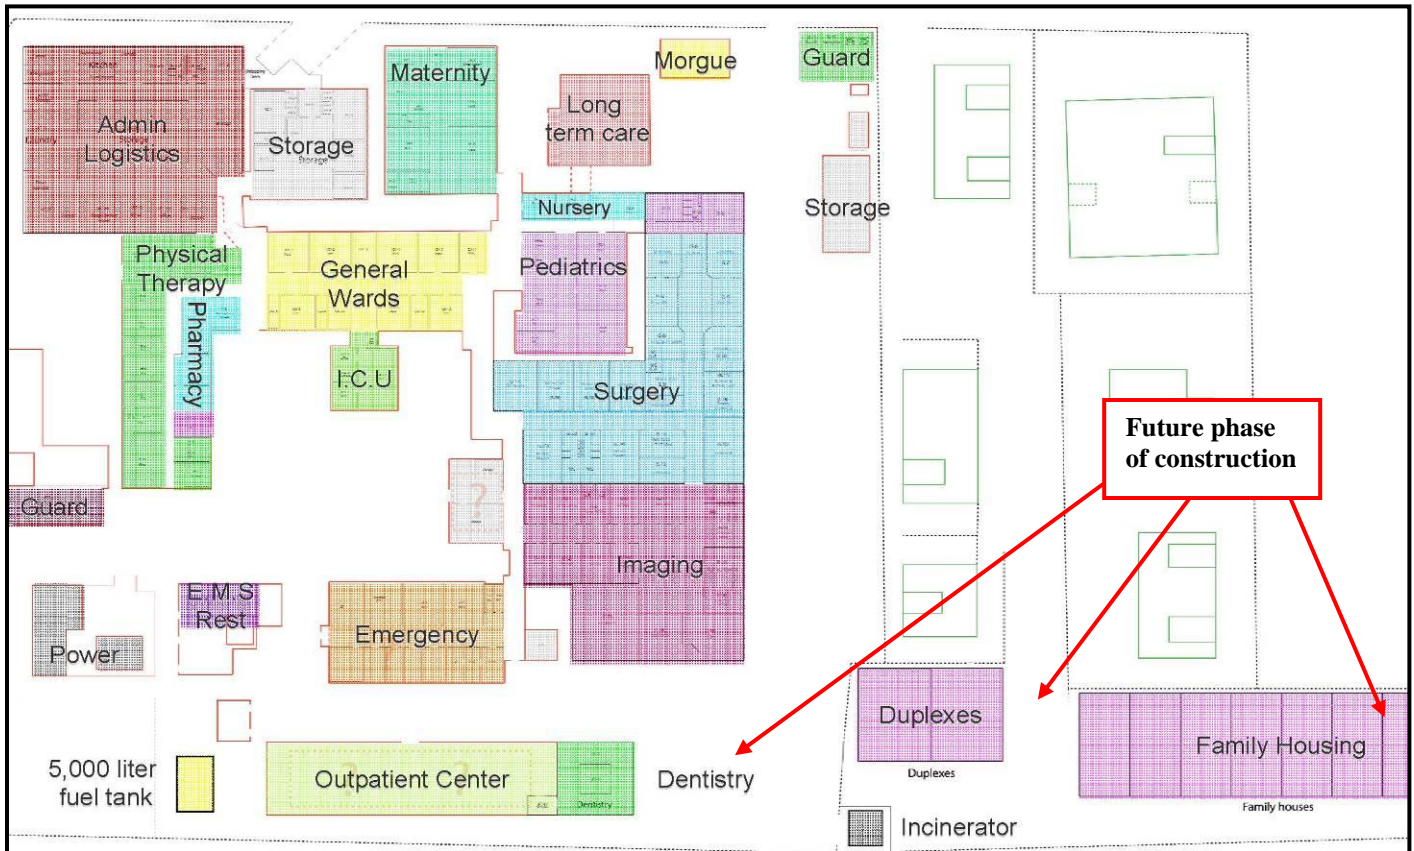
Figure 2. Illustration of Haditha General Hospital after completion of renovation and construction

The modification to the contract required the demolition of the VBIED damaged wards of the hospital as well as the existing surgery wing. The VBIED wards would be replaced by a new two-story administration and logistics building which will house the laundry, kitchen and consolidated storage on the first floor, with administration and laboratory on the second floor. The surgical wing will include three operating rooms and their supporting facilities as well as five new four bed-surgical recovery wards, three female and two male. The imagery wing will include ultrasound, x-ray and CT scanner equipment, as well as all supporting facilities.
